2011 RIVER ATLAS

SACRAMENTO RIVER BANK PROTECTION PROJECT

Appendix B To 2011 Erosion Inventory

February 2012

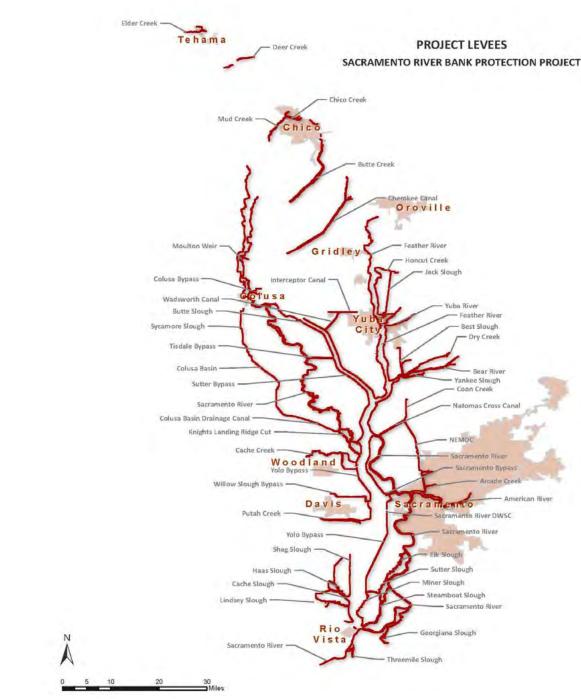
Erosion and repaired sites are identified and labeled with the abbreviated waterway and river mile (or levee mile when river mile does not exist) and bank designation. This is known as the River Code.

An example of the naming convention would be: SAC 50.6 R This translates to: Sacramento River, River Mile 50.6, Right Bank. Note: The site label is in the map plates is colored to represent the site type.
