Lower Yuba River Large Woody Material Management Plan Pilot Study

January 2014

U.S. Army Corps of Engineers Sacramento District 1325 J Street Sacramento, Ca 95814

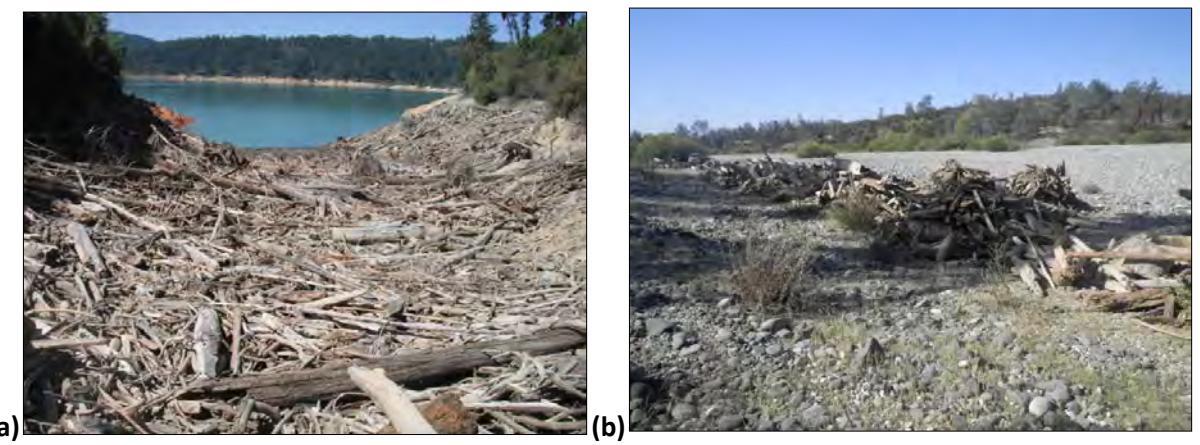
Figure 1. (a) Stockpiling of LWD in a cove at New Bullards Bar Reservoir (b) Staging area for LWM at Lower Gilt Edge Bar.

Although Englebright and Daguerre Point dams have been implicated in the deficiency of LWM in the Lower Yuba River, these dams have no management plans for LWM, which flows freely over these dams during storm events. A large quantity of LWM does accumulate in New Bullards Bar Resevoir. The Yuba County Water Agency (YCWA) presently manages the LWM that is washed into New Bullards Bar Reservoir from the North Yuba River Basin upstream. A cable-and-buoy line (floating boom) spans the reservoir just upstream of the dam, which captures woody material that has entered and traveled downstream on the reservoir's surface. Currently woody material is pushed into and stored in shallow coves of the reservoir (Figure 1).

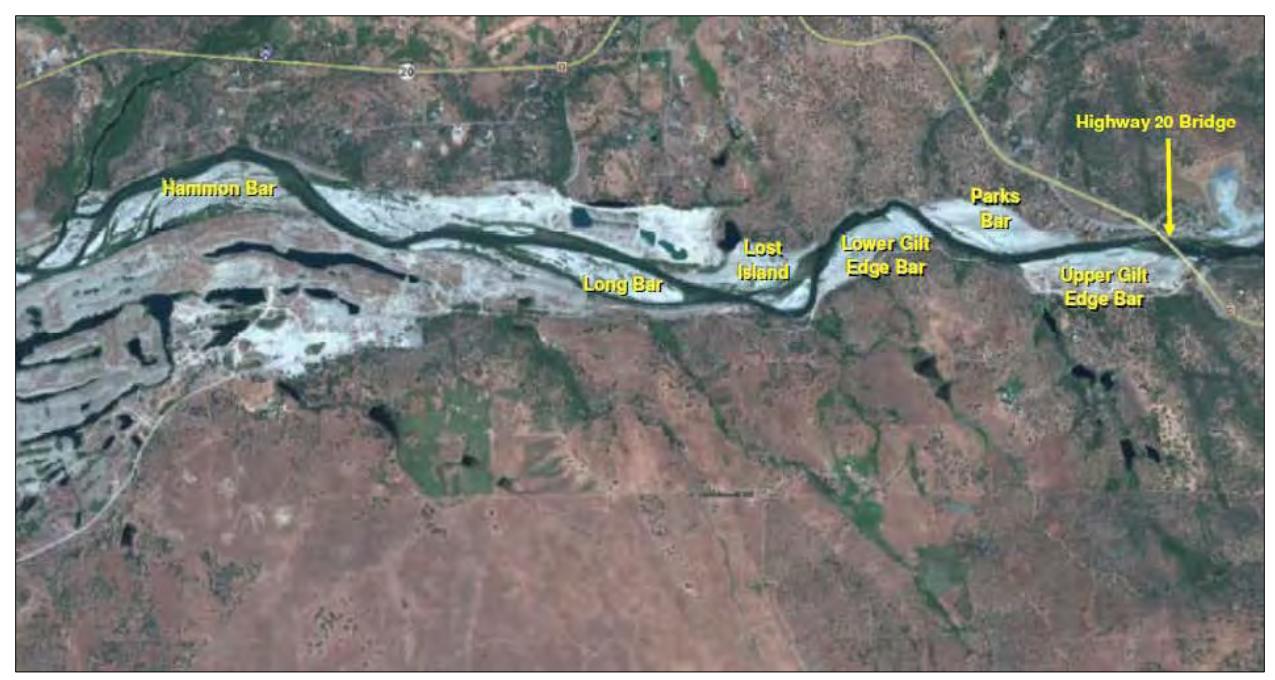
Figure 4. Proposed LWM placement areas within the Parks Bar to Hammon Bar reach of the lower Yuba River (Corps, 2012).

Prior to implementation of the LWMMP pilot study, several suitable sites had been identified along the Lower Yuba River within the Parks Bar to Hammon Bar reach, including: Upper Gilt Edge Bar, Parks bar, Lower Gilt Edge Bar, Lost Island, Long Bar, and Hammon Bar (Figure 4). Lower Gilt Edge Bar was selected as the best site for the pilot study due to ease of access and open floodplain.

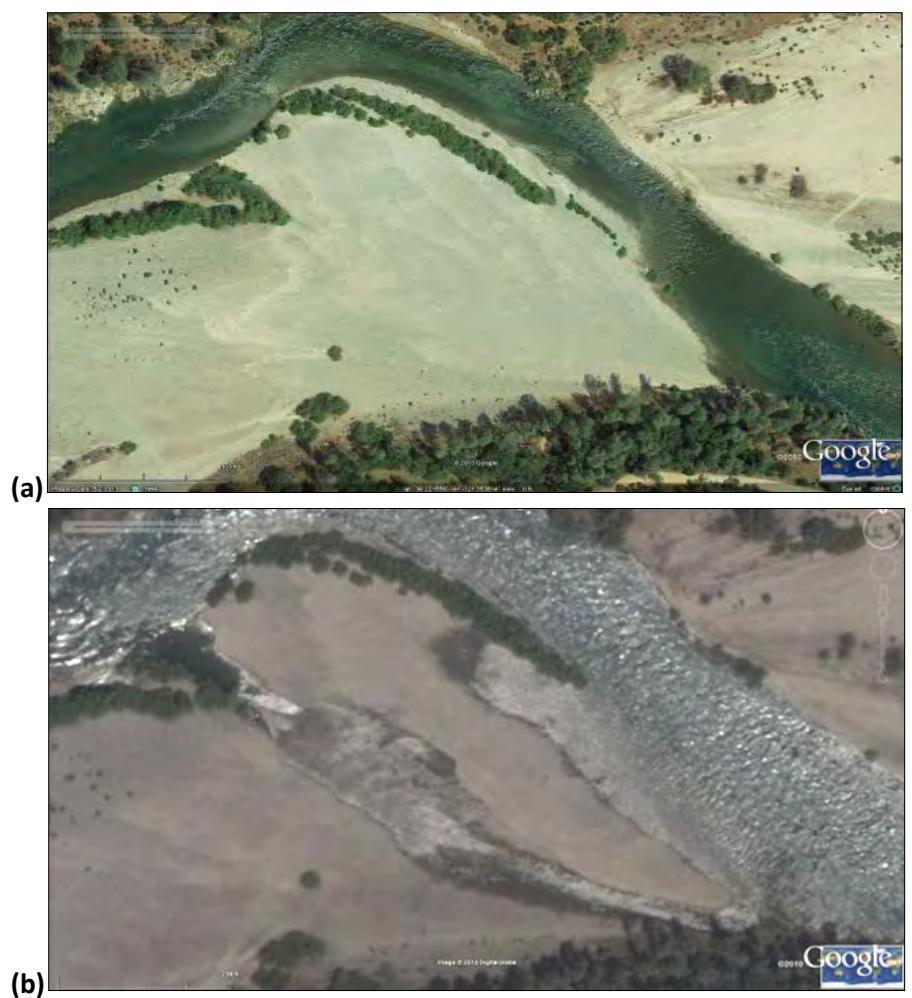
Figure 5. Various historical inundation patterns at Lower Gilt Edge Bar (a) typical low flow May 2, 2013 (b) Typical high flow June 13, 2011

Within the Lower Gilt Edge Bar site, the flood plain was evaluated by cross referencing recent historical photos and flows; areas of frequent inundation were identified and prioritized for the placement of LWM (Figure 5). The study site is primarily inundated on the upstream portion of the point bar. Significant inundation also occurs along a swale where the river cuts across Lower Gilt Edge Bar. The upstream edge and swale areas of the study site will be priority locations for the placement of LWM.

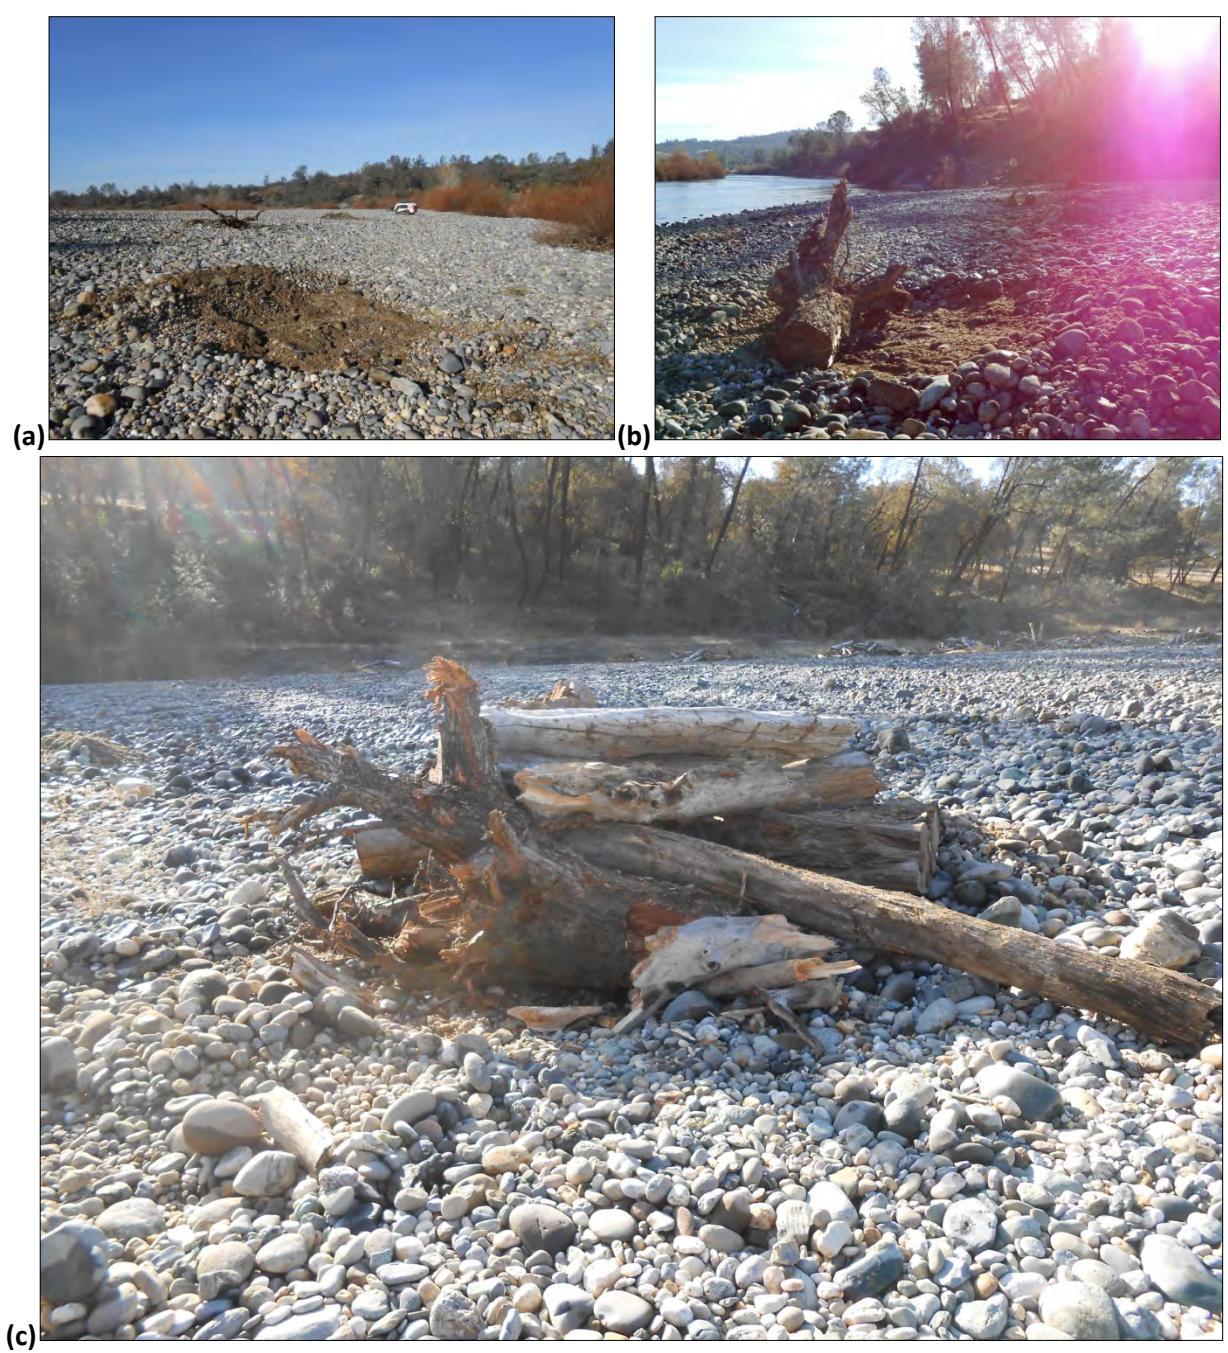
Figure 6. Typical LWM pile construction **(a)** Shallow pit prior to placement of LWM **(b)** Placement of Key Piece **(c)** complete LWM pile after addition of assorted debris

Specific sites for placing piles of LWM were selected to provide various subjection of LWM to natural flows. Pile locations vary in elevation and relative location on the point bar. With these concerns in mind all large debris piles were constructed using the same general methods (Figure 6). First a shallow pit was formed using a bobcat. Secondly, using an excavator, a key piece of LWM was transported from the staging area and placed into the shallow pit at the direction of Corps staff. Key pieces were generally oriented perpendicular to the predicted direction of high flows. Key pieces were selected for their large size or presence of root wad and are expected to provide significant stability. After placement of the key piece(s), assorted pieces were then placed onto and around the key piece to form a complex structure. Although this method was followed for all piles, each pile is unique in number of pieces and pile complexity. LWM piles were categorized as Root Wad, Log Jam, or Small Debris Pile depending on composition. In general piles were not anchored or stabilized beyond their inherent stability. The exception to this is Log Jam 5, which was ballasted with a small amount of cobble to prop the ends of the key pieces above the ground.

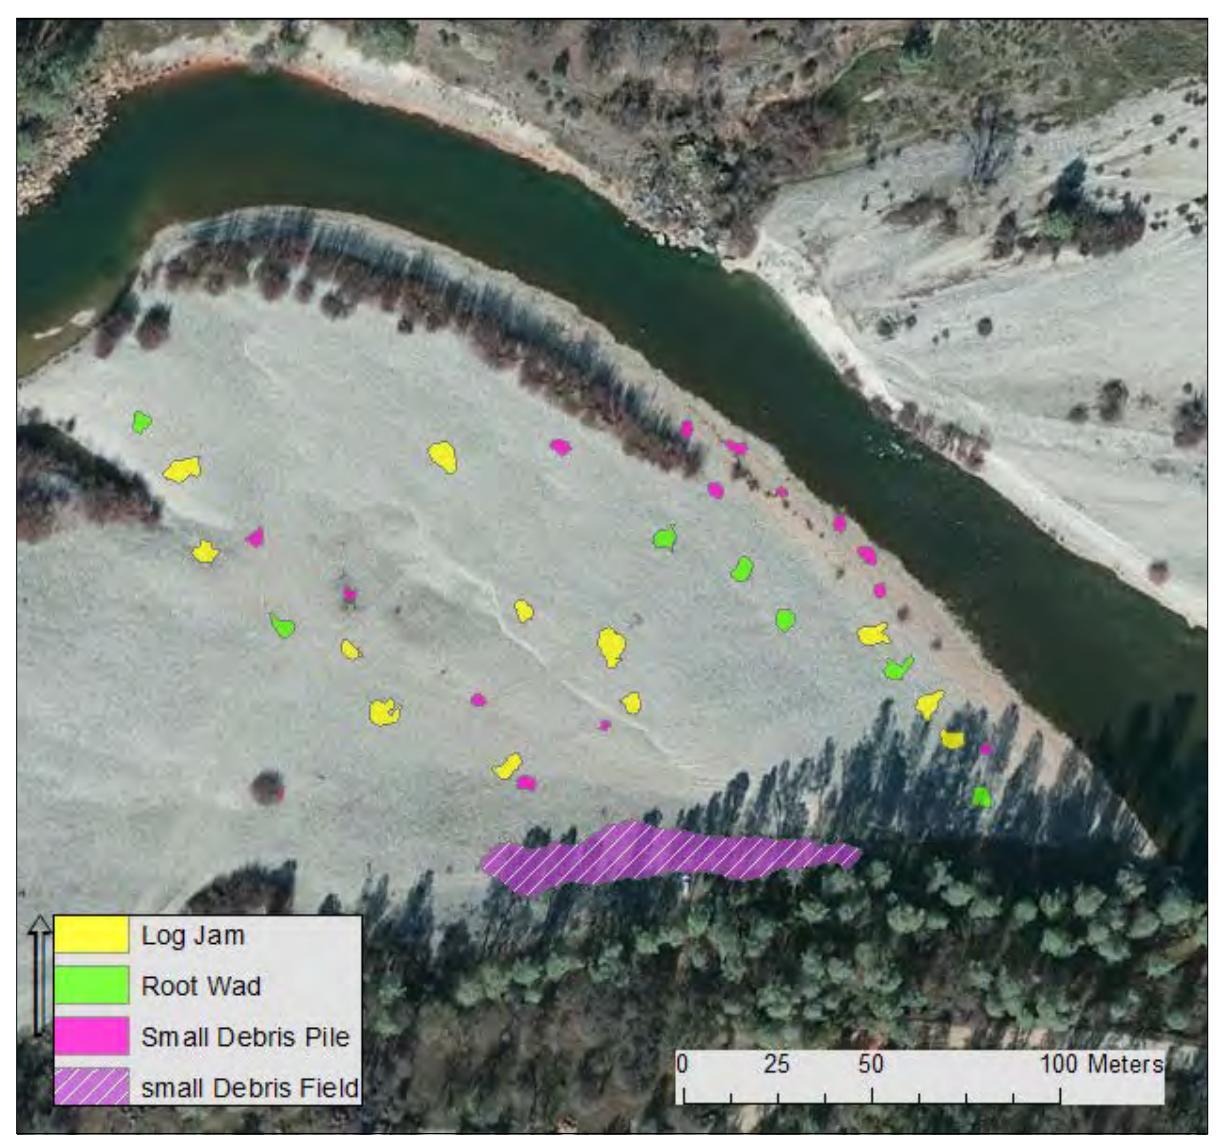
Figure 7. LWM Placement on Lower Gilt Edge Bar

From 10/21/2013 – 10/25/2013, woody material was transported from New Bullards Bar Reservoir to a staging area at Lower Gilt Edge Bar. From 12/10/2013 – 12/11/2013 LWM was placed on the Lower Gilt Edge Bar on the Lower Yuba River (Figure 7). LWM was distributed into 7 Root Wad piles, 12 Log Jam piles, and 15 small debris piles (Table 1). A field of scattered small debris remains on the foot print of the LWM staging area. Piles were placed on the flood plain between 182 and 191ft elevation.

After placing the LWM into piles, the total area covered by woody material, including the remnants of the staging pile was 19046 ft² (0.44 acres). The total area covered by log jams is 4220 ft² (0.097 acres). The total area covered by root wad piles is 1775 ft² (0.041 acres). The total area covered by small debris piles is 1755 ft² (0.04 acres). The remnants of the staging pile, consists of small debris and covers 11295 ft² (0.3 acres).
