American River Watershed, California  
Long-Term Study  
Final Supplemental Plan Formulation Report/  
EIS/EIR

ARDEN BAR SITE  
PROBLEMS AND OPPORTUNITIES

Sacramento District, Corps of Engineers  
February 2002

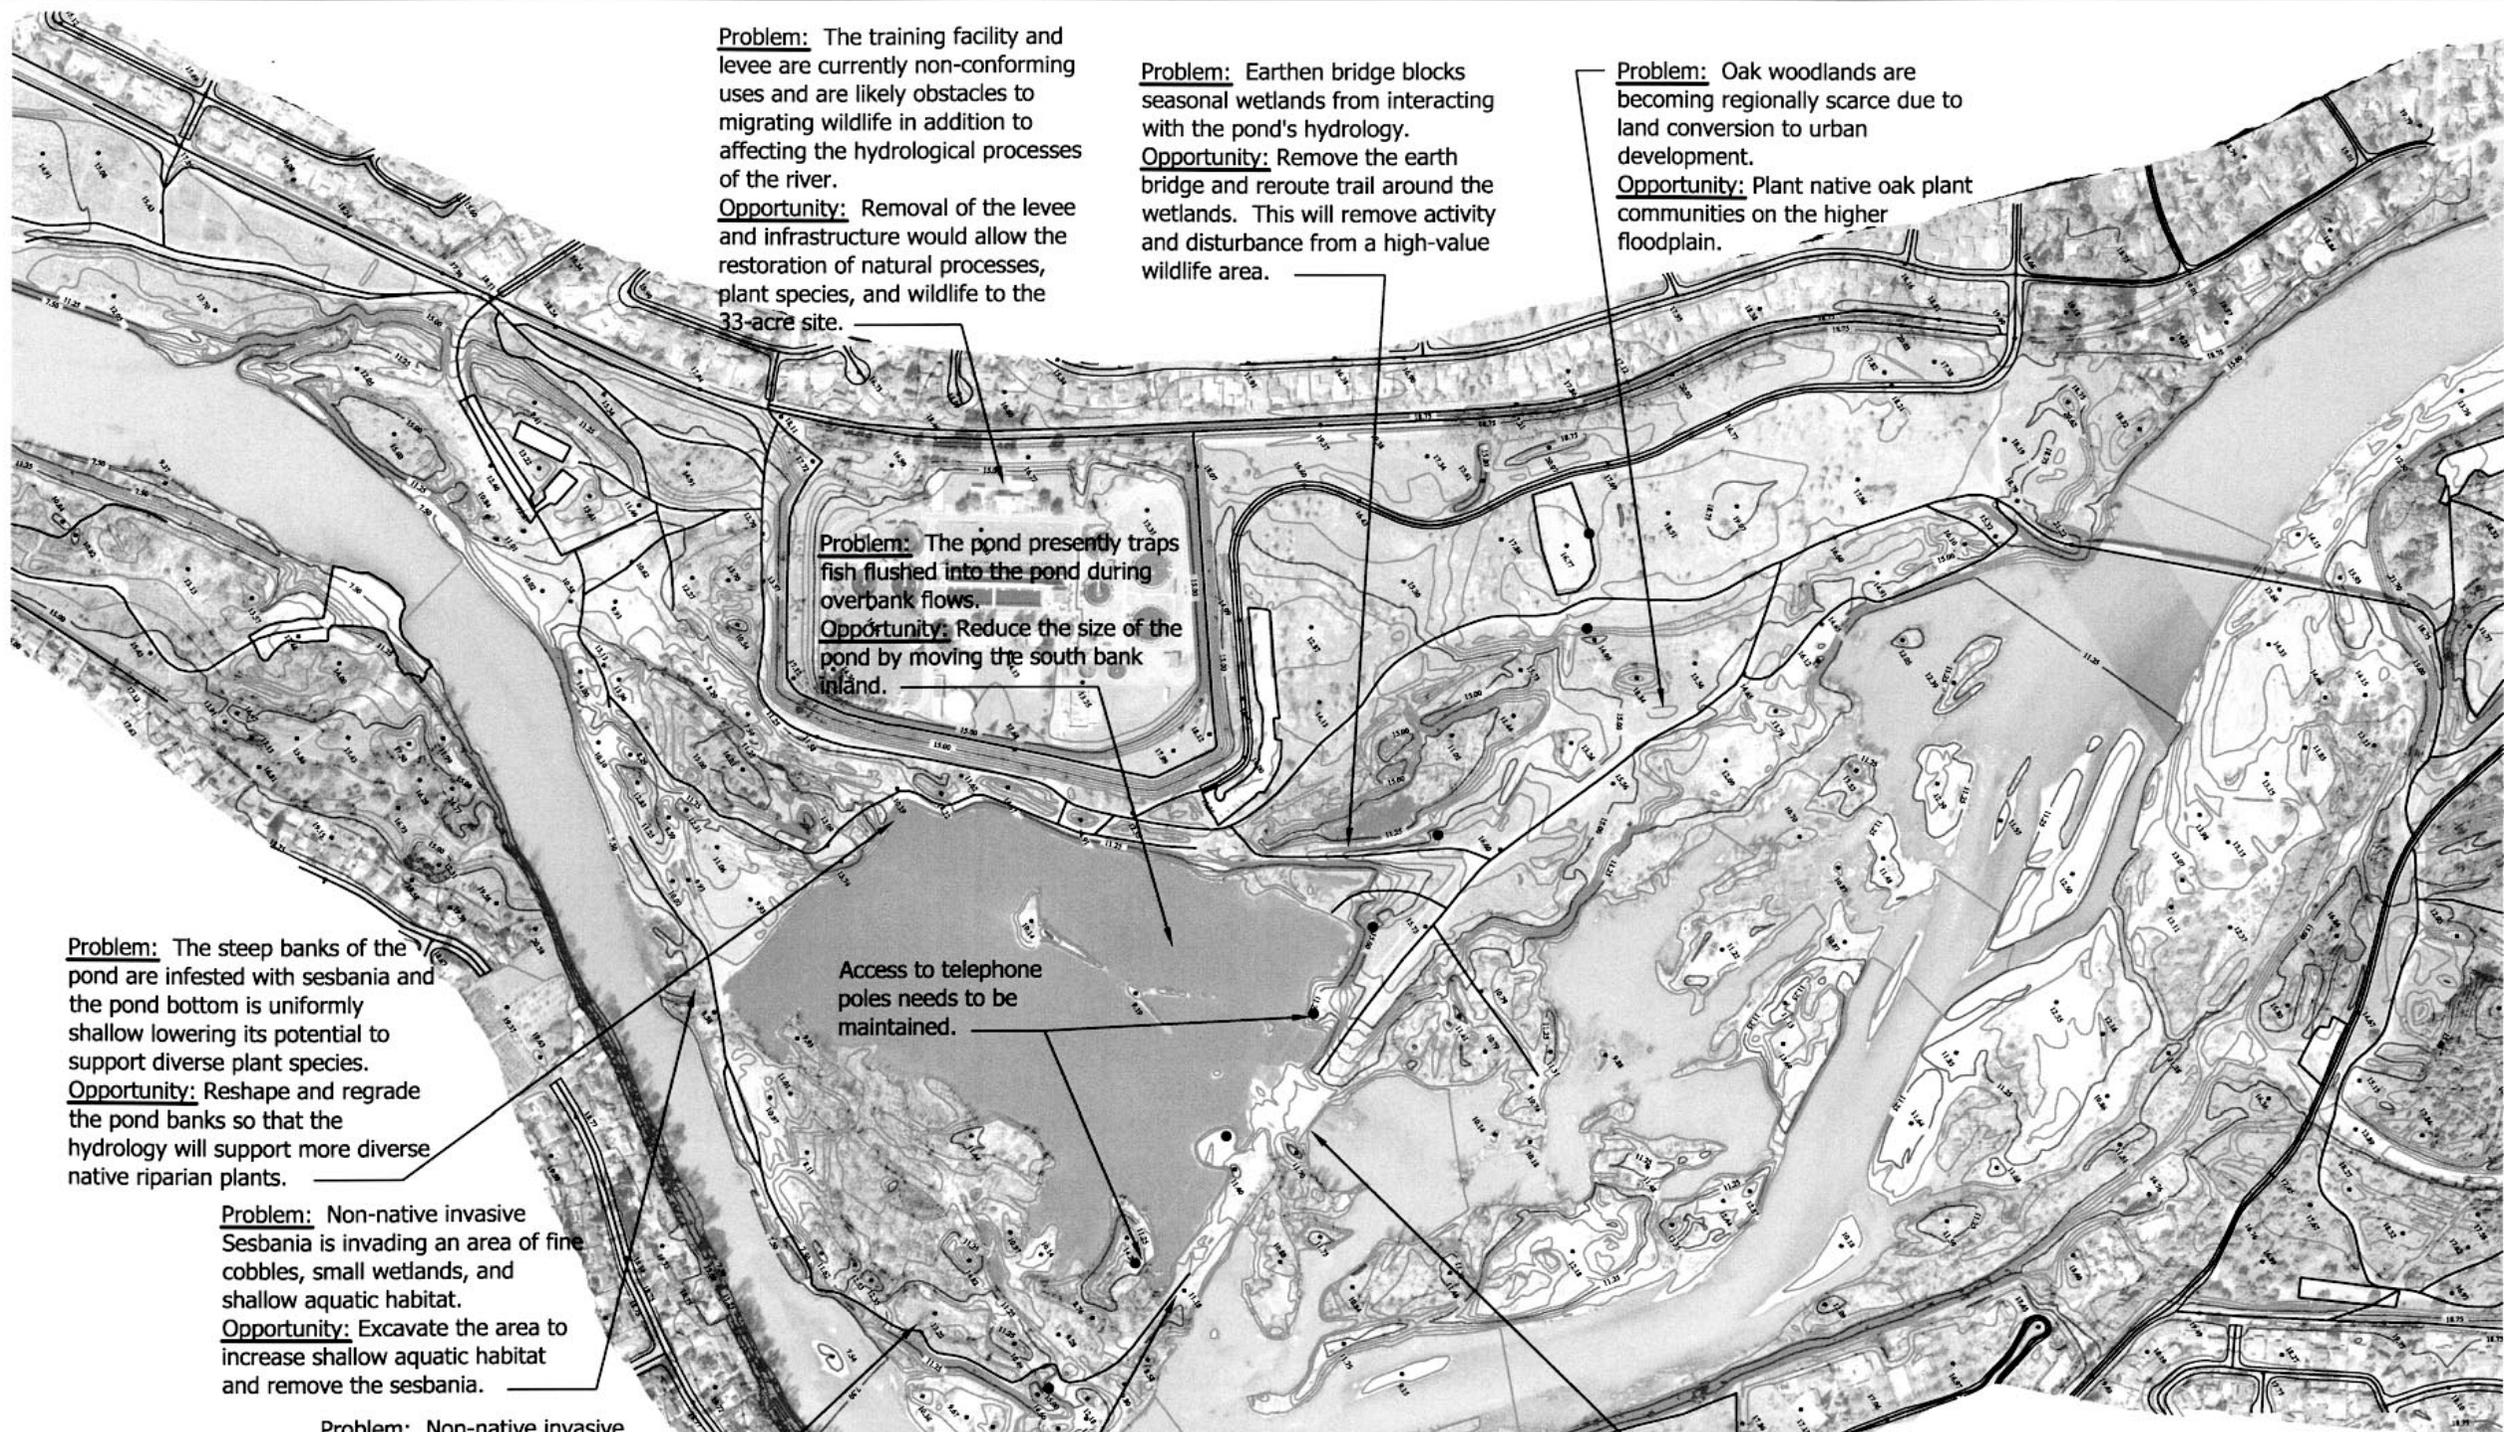
**Problem:** The training facility and levee are currently non-conforming uses and are likely obstacles to migrating wildlife in addition to affecting the hydrological processes of the river.

**Opportunity:** Removal of the levee and infrastructure would allow the restoration of natural processes, plant species, and wildlife to the 33-acre site.

**Problem:** Earthen bridge blocks seasonal wetlands from interacting with the pond's hydrology.

**Opportunity:** Remove the earth bridge and reroute trail around the wetlands. This will remove activity and disturbance from a high-value wildlife area.

**Problem:** Oak woodlands are becoming regionally scarce due to land conversion to urban development.

**Opportunity:** Plant native oak plant communities on the higher floodplain.

**Problem:** The pond presently traps fish flushed into the pond during overbank flows.

**Opportunity:** Reduce the size of the pond by moving the south bank inland.

Access to telephone poles needs to be maintained.

**Problem:** The steep banks of the pond are infested with sesbania and the pond bottom is uniformly shallow lowering its potential to support diverse plant species.

**Opportunity:** Reshape and regrade the pond banks so that the hydrology will support more diverse native riparian plants.

**Problem:** Non-native invasive Sesbania is invading an area of fine cobbles, small wetlands, and shallow aquatic habitat.

**Opportunity:** Excavate the area to increase shallow aquatic habitat and remove the sesbania.

**Problem:** Non-native invasive Starthistle has begun infesting this small area.

**Opportunity:** Remove the yellow starthistle and plant native oak woodland plant species.

**Problem:** The south bank of the river is steep and rapidly eroding, threatening property and valuable spawning gravels in the river.

**Opportunity:** Alleviate pressure on south bank by constructing a high-flow bypass through the point bar on the north bank. The bypass could be constructed to incorporate wildlife habitat values.

**Problem:** The access road separating the river from the pond is easily breached at low flows and carries fish into the pond, trapping them.

**Opportunity:** Stabilize the road by filling it, raising its elevation, and creating a more natural slope on the river side; plant adjacent areas with native plant species.
