American River Watershed, California
 Long-Term Study
 Final Supplemental Plan Formulation Report/
 EIS/EIR

URRUTIA SITE
 WITHOUT-PROJECT CONDITIONS

Sacramento District, Corps of Engineers
 February 2002

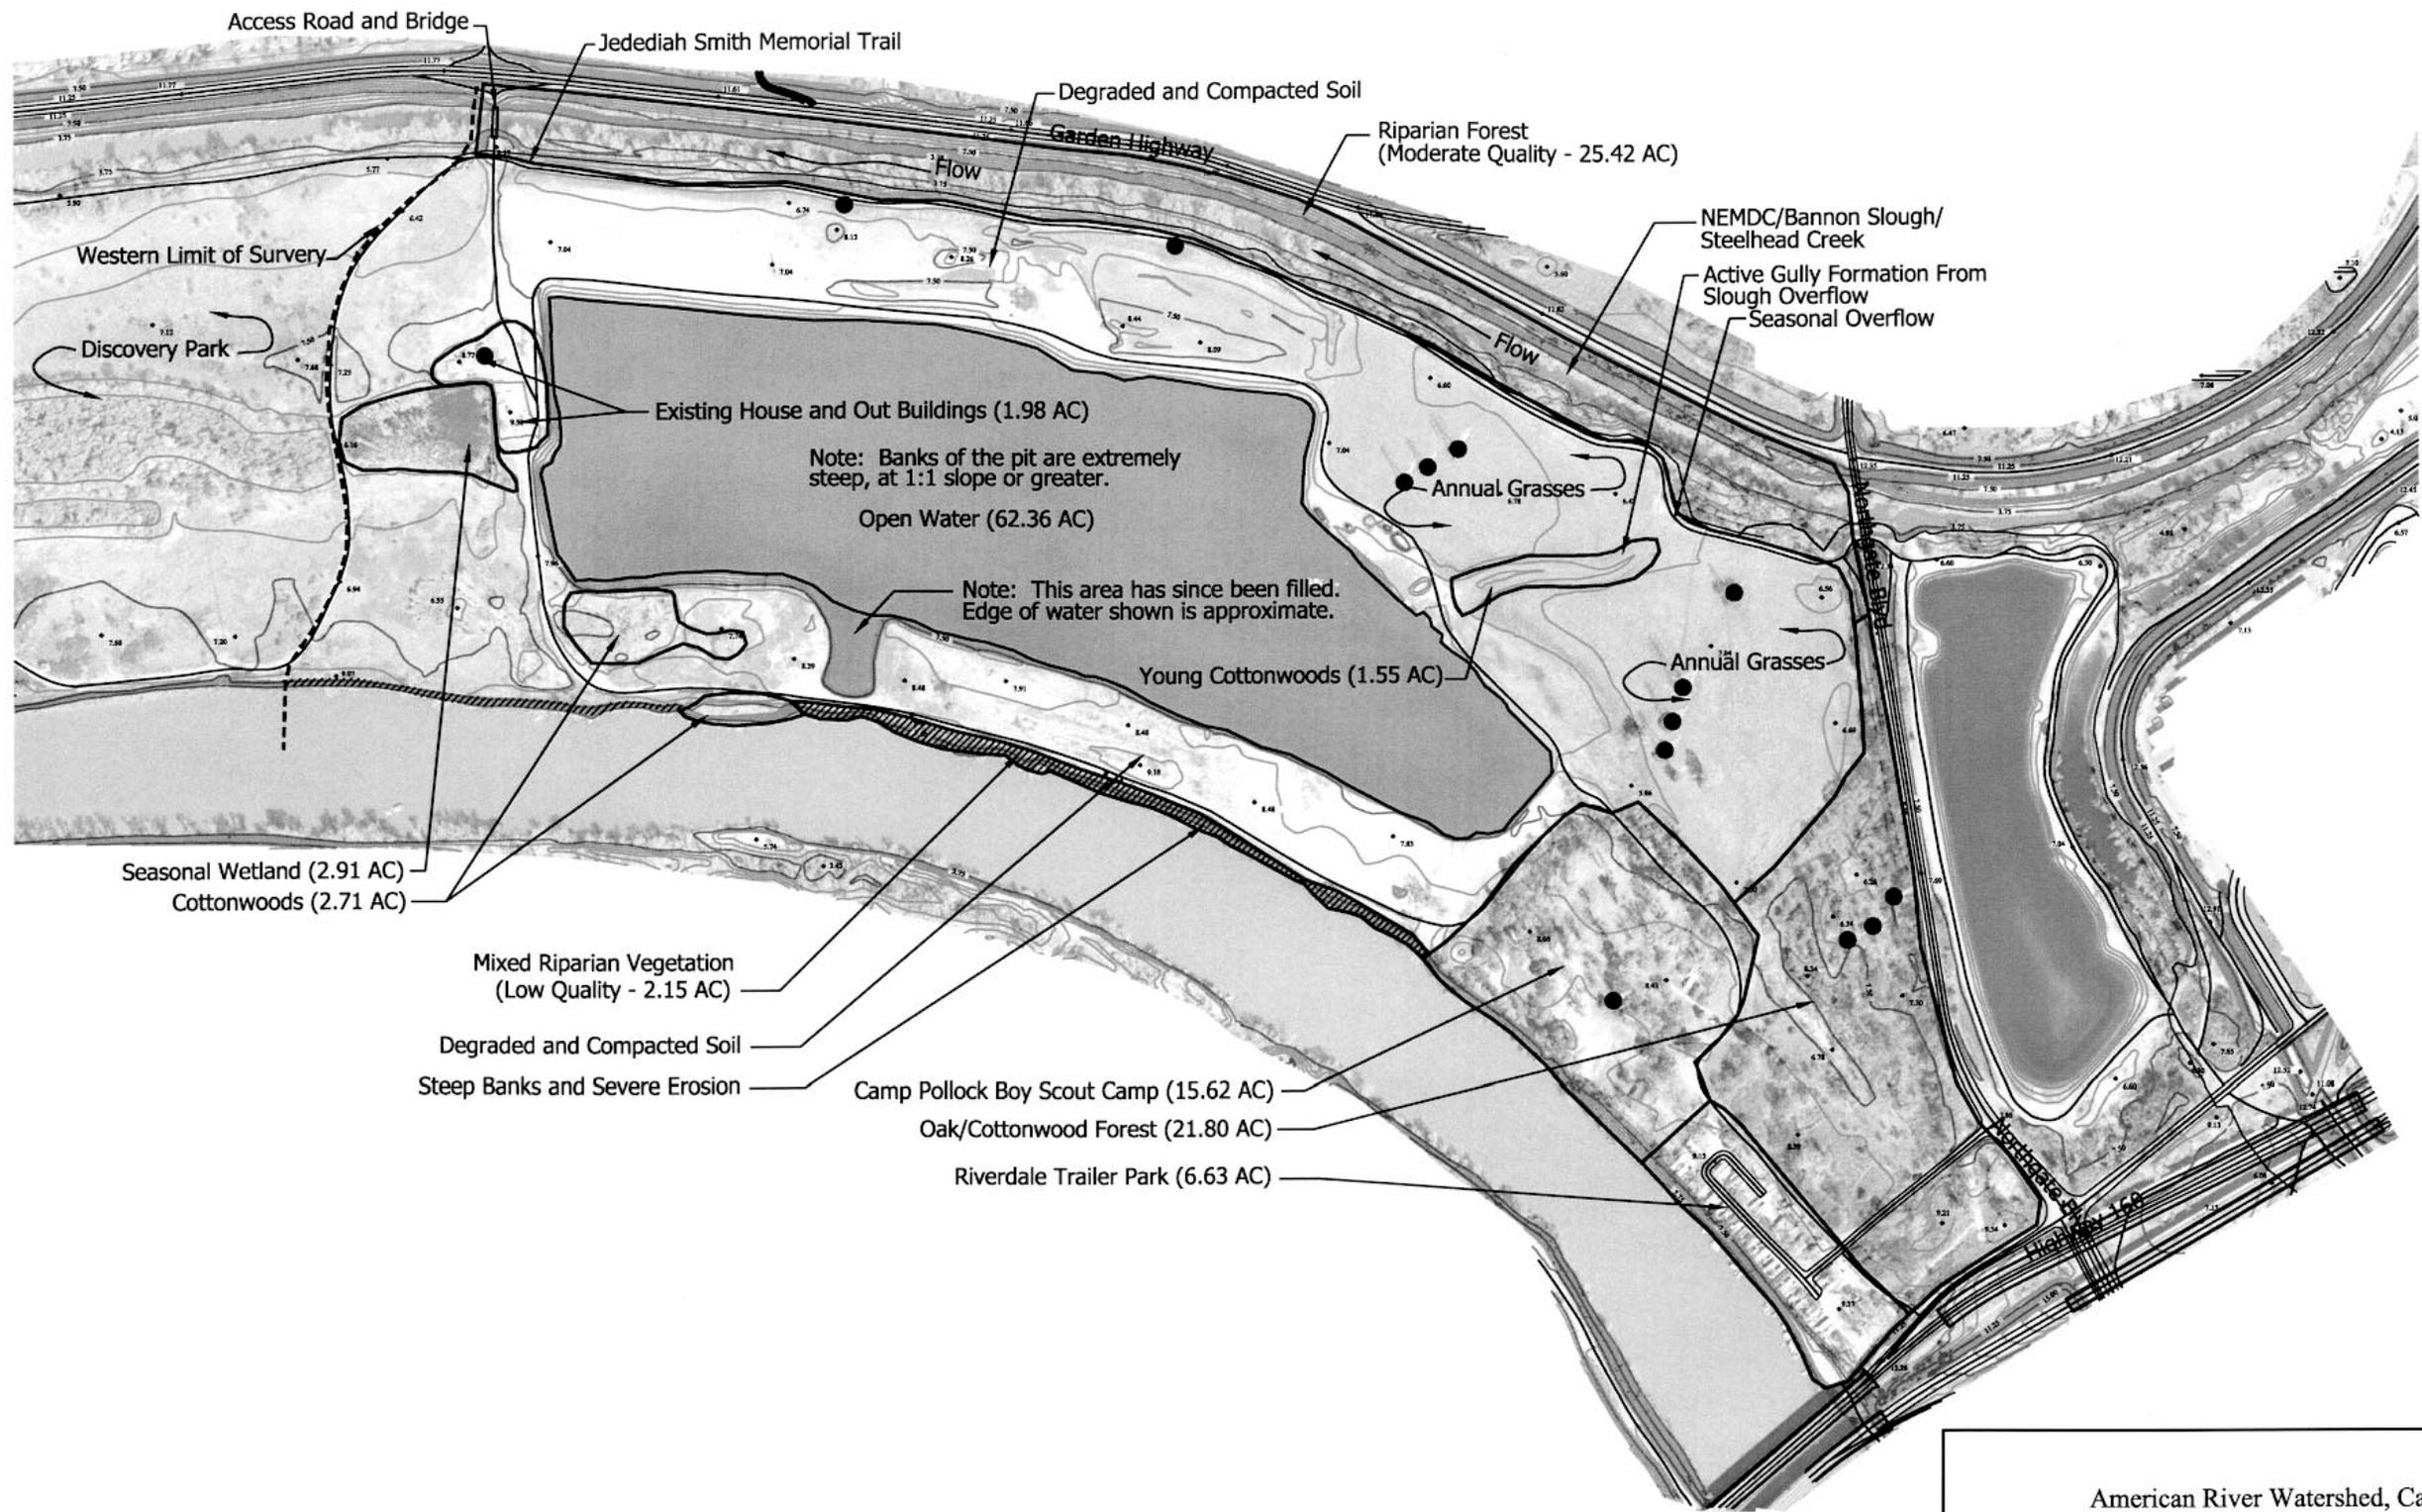
Existing House and Out Buildings (1.98 AC)
 Note: Banks of the pit are extremely steep, at 1:1 slope or greater.
 Open Water (62.36 AC)

Note: This area has since been filled. Edge of water shown is approximate.

Young Cottonwoods (1.55 AC)

Seasonal Wetland (2.91 AC)
 Cottonwoods (2.71 AC)

Mixed Riparian Vegetation
 (Low Quality - 2.15 AC)

Degraded and Compacted Soil
 Steep Banks and Severe Erosion

Camp Pollock Boy Scout Camp (15.62 AC)

Oak/Cottonwood Forest (21.80 AC)

Riverdale Trailer Park (6.63 AC)

Note: Map contours are shown in meters
 Contour interval = 3.75 meters (12.3 feet)
